Developing Dynamic Web-GIS based Early Warning System for the Communities Living with Landslide Risks in Chittagong Metropolitan Area, Bangladesh

BUET-Japan Institute of Disaster Prevention and Urban Safety (BUET-JIDPUS)
Bangladesh University of Engineering and Technology (BUET)

17 September 2015

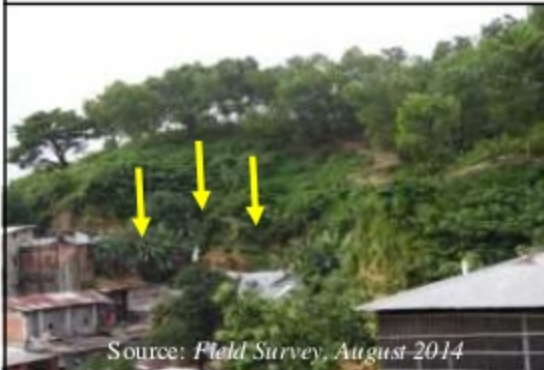
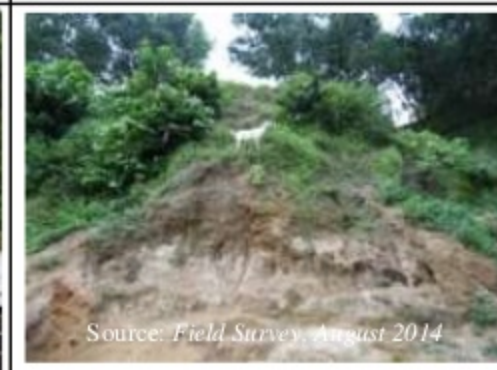
Landslide ID : 05

Landslide Location: Tanker Pahar, Moti Jharna

Type of Movement: Slide

Material: Soil/Earth

Hill cutting is the major issue that caused landslide in this area and intense rainfall acted as a triggering factor for landslide.

Landslide in this site occurred in 1982, 1989, 1991, 1994, 1996 and 2013. 10 houses got damaged and almost 22 people died due to landslide at different periods. Utility facilities were highly damaged in this incident. Economic activities were hampered so does the social life of people. Environment has been found to be severely damaged. Still there are many houses located at the down slope of the hill. Soil of this site has been found to be sandy. The escapement slope is found to be near vertical. The failed mass is a part of upper portion. Vertical Slope characteristics can be considered as a contributing factor to future landslide for this hill. Settlements located at the down slope of this hill are at a huge risk of massive landslide. The risk is high (Field survey, August 2014).

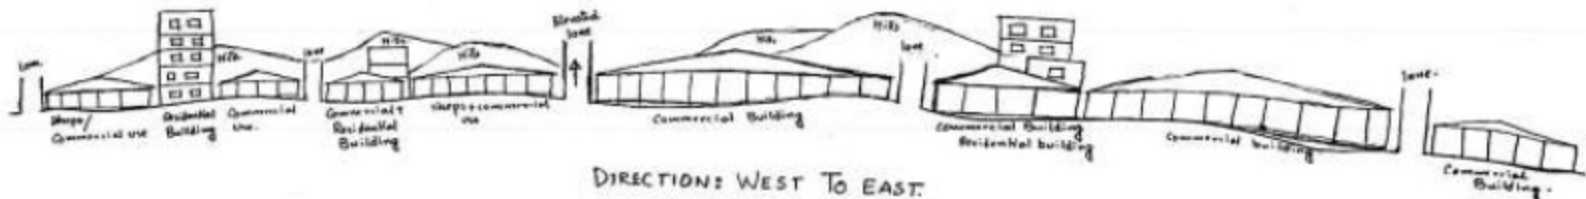
DIRECTION : EAST TO WEST
