Ground Strengthened and Building Re-Levelled at Large Shopping Centre

PROJECT PROFILE

Z15Y036

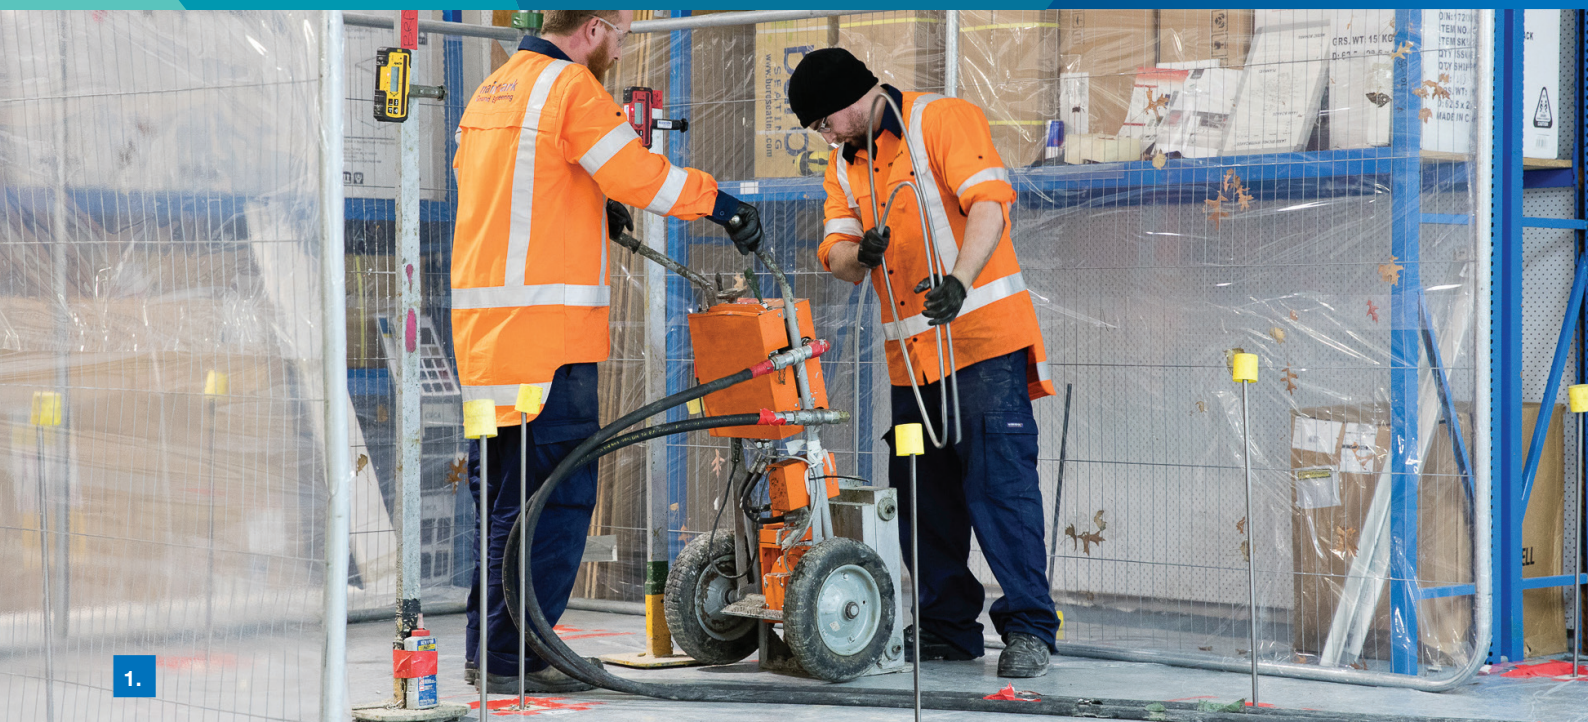
Pictured above:
1. Keyhole Terefirm®
Resin Injection delivery in
progress.

Mainmark's Terefirm® Resin Injection for liquefaction mitigation is the only solution of its kind and can be applied retrospectively beneath existing buildings or structures. The ground beneath the Northwood Supa Centa was treated via more than 3,000 injection points to a depth of between 4m to 8m below ground level, and across the building's footprint.

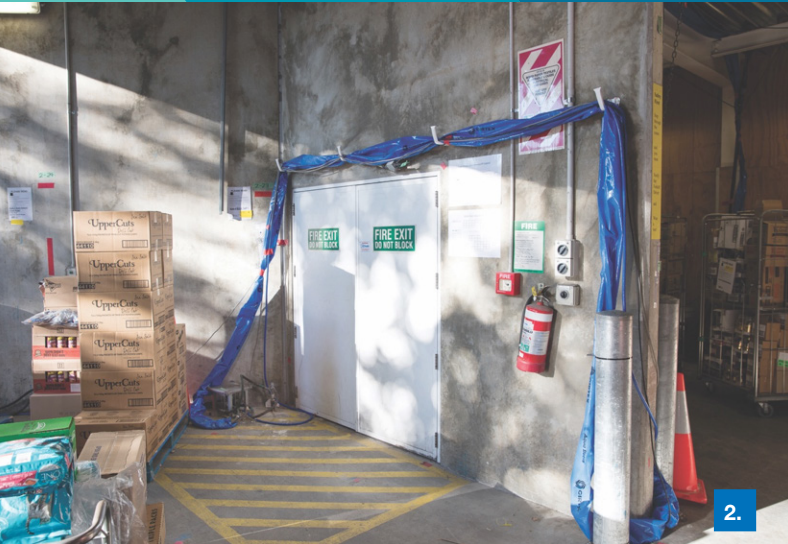
2. Customised installation of required hoses and cables allowed tenants to remain fully operational during the project without compromising health and safety. 3. Internal injection works carried out at night; full store operations restored by opening everyday.
